**A STUDY OF THE CONDITION OF
PIEZOMETERS IN THE 1949 INSTALLATION
AT REID-BEDFORD, LOUISIANA**

J. L. McCall

November 1968

**U. S. Army Engineer Waterways Experiment Station
CORPS OF ENGINEERS
Vicksburg, Mississippi**

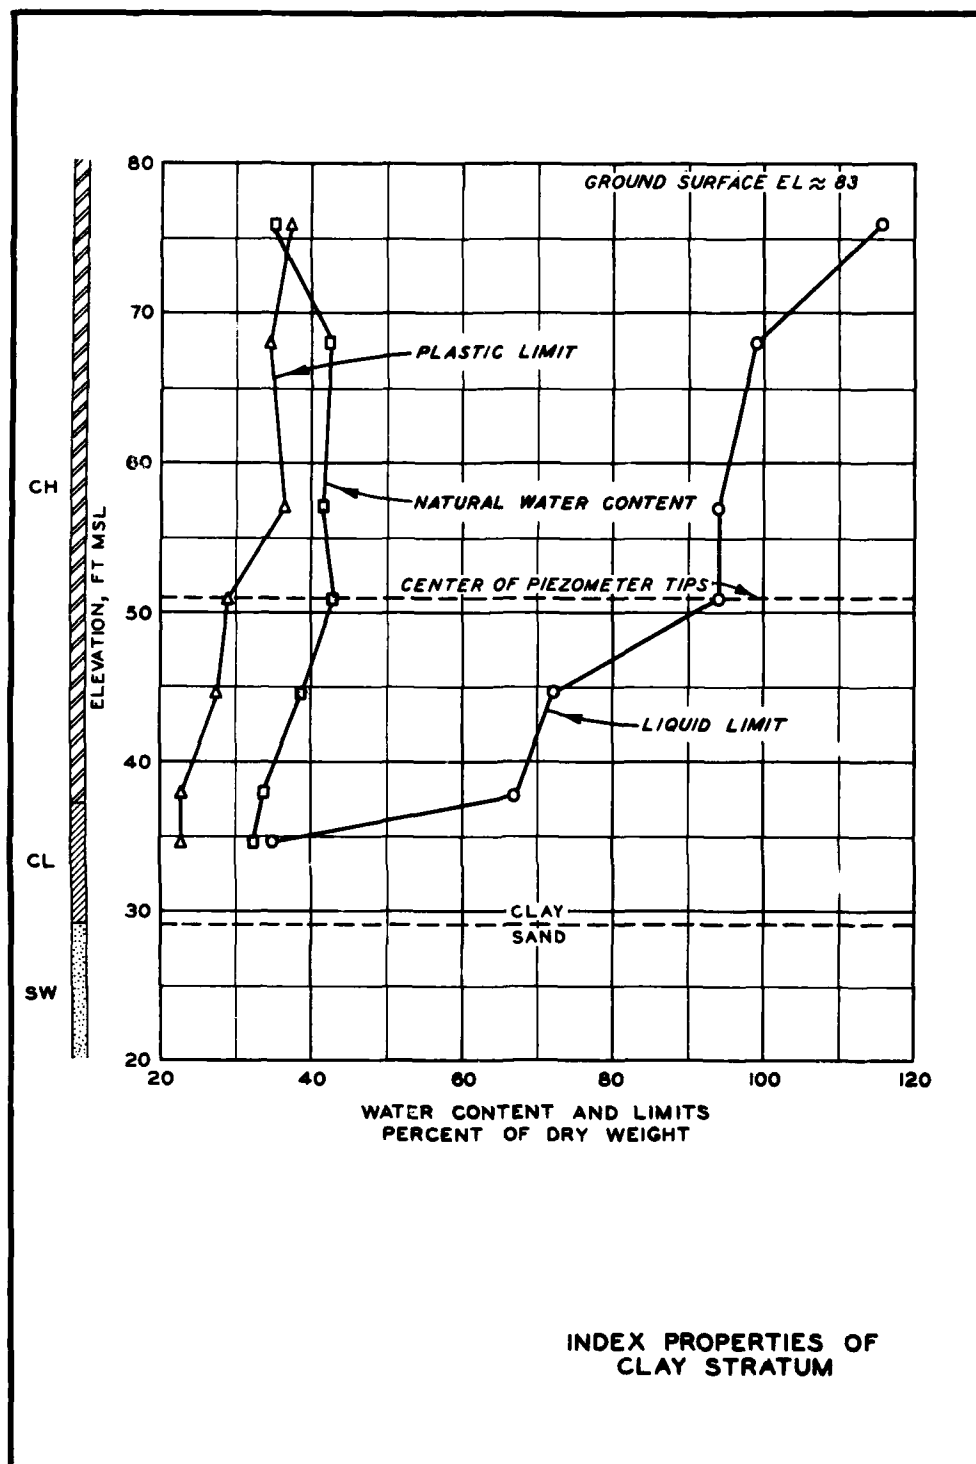
PLATE 2

5. The piezometers installed in early 1949 were located on the land-side toe of the Mississippi River levee about 4 miles* downstream from the Vicksburg Bridge and near Mound, La. (plate 1). The installation was made in a backswamp deposit, approximately 50 ft thick, that had been formed by the overflow from the river and subsequent deposition of fine-grained soils (CH and CL) over a period of many years. Natural water content and Atterberg limits data for the deposit are shown in plate 2.
